Pentium® II Xeon™ Processor Specification Update

Release Date: June 1999

Order Number: 243776-013

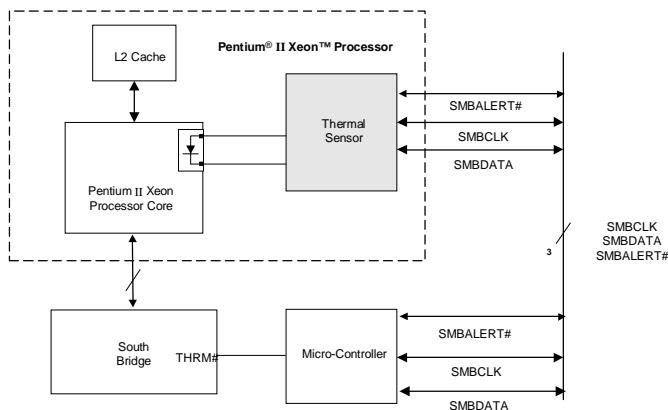
Figure 1. An Example of Microcontroller Driven Thermal Management

D30. Thermal Sensor May Assert SMBALERT# Incorrectly

PROBLEM: The Pentium II Xeon processor has a thermal sensor that monitors the processor core's temperature. The thermal sensor asserts SMBALERT# if the processor temperature exceeds the temperature limits set in the Alarm Threshold Registers (T_{HIGH} , T_{LOW}). It also sets the corresponding Status Register bits to identify the cause of the interrupt. Figure 1 gives one example of the how the SMBALERT# signal could be used in a system.

Under the conditions described below, the thermal sensor incorrectly generates the SMBALERT# interrupt. *All* of the following conditions must be met to trigger a false interrupt:
